# Service Information

Category <b>R</b>	<b>Repair Guidance</b>	Ref. No. R114/15 <b>B</b>	Page 1 of 4
Coverage <input type="checkbox"/> Distributor only <input checked="" type="checkbox"/> Please inform your dealers		Date Issued December 8, 2015	
Please convey this information to your <input type="checkbox"/> Director <input checked="" type="checkbox"/> General Manager <input checked="" type="checkbox"/> Warranty Dept. <input checked="" type="checkbox"/> Parts Dept. <input checked="" type="checkbox"/> Training Dept. <input checked="" type="checkbox"/> Field Rep.		Date Revised July 14, 2016	
Applicable Model  CX-3 (DK)		Applicable Countries or Specifications  Worldwide

## Subject: Creaking noise from front shock absorber

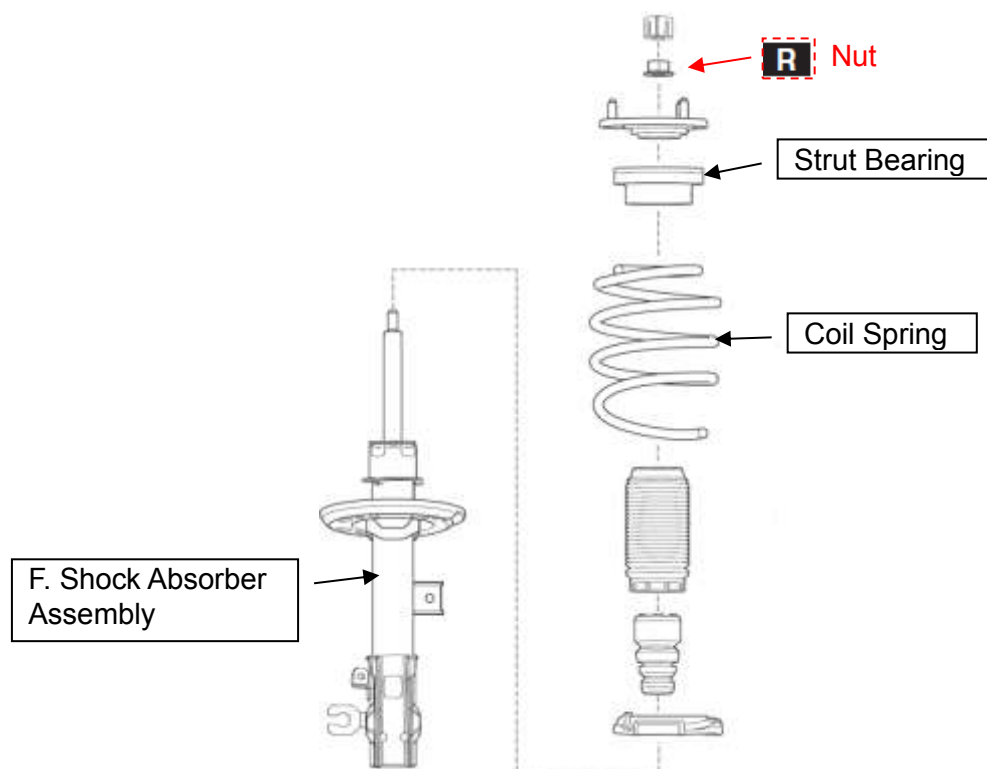
The creaking noise may be caused by stick-slip between the front strut bearing and the coil spring.

The shape of the coil spring has been changed.
