Service Information

Category T	Repair Guidance	Ref. No. R006/16	Page 1 of 5
Coverage <input type="checkbox"/> Distributor only <input checked="" type="checkbox"/> Please inform your dealers		Date Issued February 4, 2016	
Please convey this information to your <input type="checkbox"/> Director <input checked="" type="checkbox"/> General Manager <input checked="" type="checkbox"/> Warranty Dept. <input checked="" type="checkbox"/> Parts Dept. <input checked="" type="checkbox"/> Training Dept. <input checked="" type="checkbox"/> Field Rep.		Date Revised	
Applicable Model Mazda2 (DJ), Mazda3 (BM), Mazda6 (GJ), CX-3 (DK), CX-5 (KE) and MX-5 (ND) with MZD Connect		Applicable Countries or Specifications Europe, ADR and 4A Where Connected Service is available

Subject: MZD Connect fails to establish Wi-Fi connection

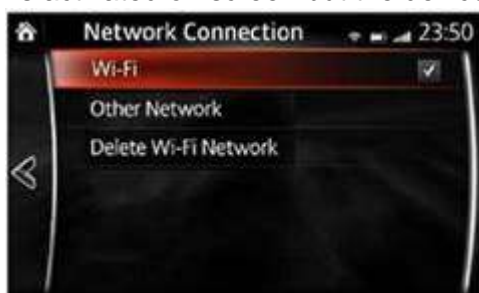
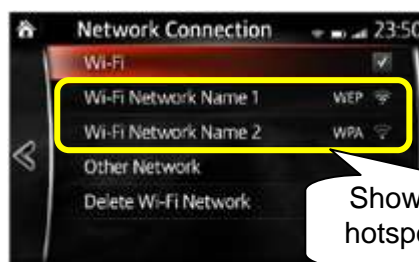
Symptom A.

Wi-Fi is activated on screen but the device's Wi-Fi hotspot is not detected.

Shown when Wi-Fi hotspot is detected.

Electromagnetic noise generated in the connectivity master unit (CMU) hardware may disturb the Wi-Fi connection.

Replace the CMU with a modified one according to the Workshop Manual "CONNECTIVITY MASTER UNIT (CMU) REMOVAL/INSTALLATION".

Update the new CMU's software version to latest level if necessary. Refer to Service Information R115/13.

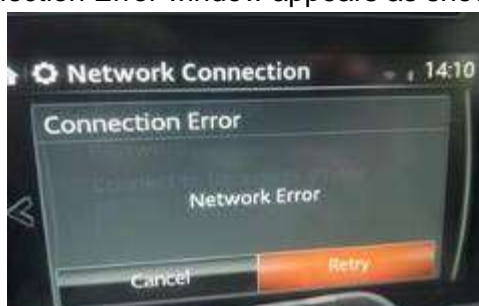
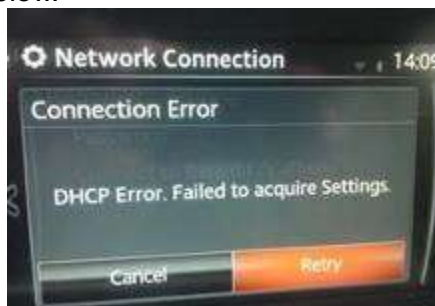
Symptom B.

The device's Wi-Fi hotspot is detected but the network connection fails.
Connection Error window appears as shown below.

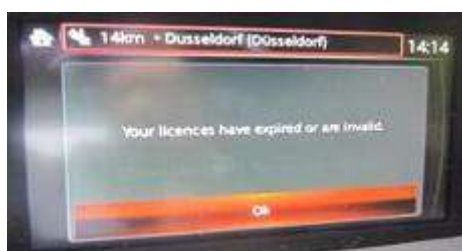
"Your licences have expired or are invalid."

Improper software.

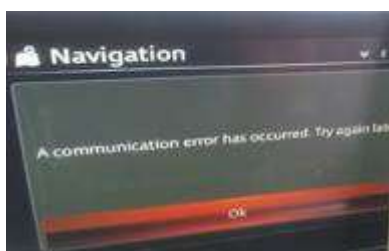
"A communication error has occurred. Try again later."

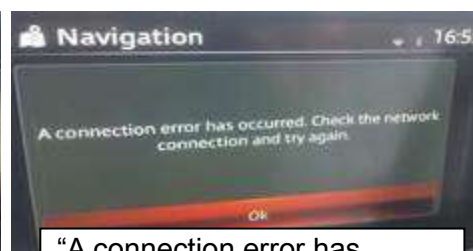
"A connection error has occurred. Check the network connection and try again."
