Subject: MAZDA CONNECT INTERMITTENT AUDIO NO SOUND AND/OR STATIC NOISE FROM SPEAKERS	Service Alert No.: SA-070/22
	Last Issued : 11/01/2022

2020-2023 CX-30

2019-2023 Mazda3

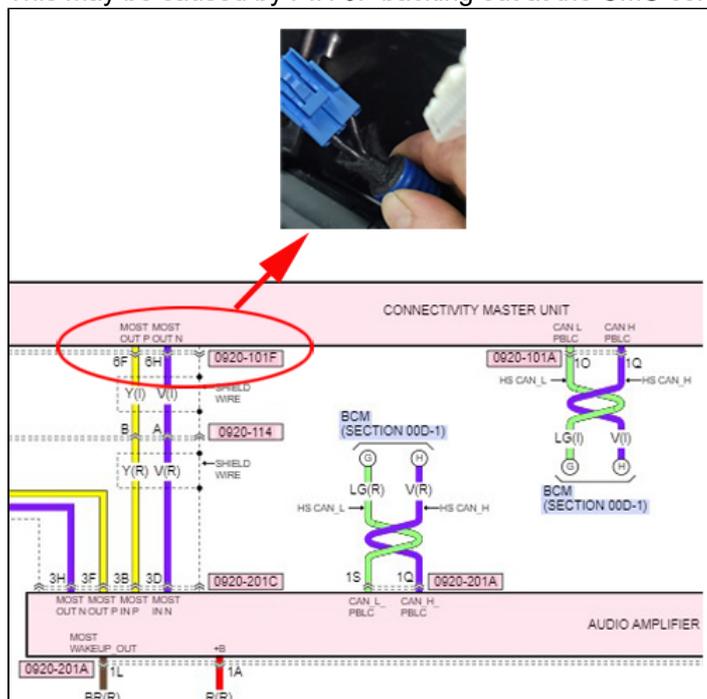
Some customers may complain about intermittent audio no sound from the MAZDA CONNECT infotainment system and/or static noise from the speakers. The concern may be reproduced by tapping on the dash pad near the MAZDA CONNECT center display and the following DTC's may be stored.

- U0186:08 Communication error with audio amplifier
- U2145:08 Communication error with remote tuner (RT)
- U2145:02 Communication error with remote tuner (RT)

This may be caused by PIN 6F backing out at the CMU connector 0920-101F.
