# Service Information

Category <b>R</b>	<b>Repair Guidance</b>	Ref. No. R025/13B	Page 1 of 2
Coverage <input type="checkbox"/> Distributor only <input checked="" type="checkbox"/> Please inform your dealers		Date Issued March 25, 2013	
Please convey this information to your <input type="checkbox"/> Director <input checked="" type="checkbox"/> General Manager <input checked="" type="checkbox"/> Warranty Dept. <input checked="" type="checkbox"/> Parts Dept. <input checked="" type="checkbox"/> Training Dept. <input checked="" type="checkbox"/> Field Rep.		Date Revised May 21, 2013	
Applicable Model  CX-5 (KE)		Applicable Countries or Specifications  Worldwide

## Subject: Knocking/Squeaking Noise from Front Strut Bearing

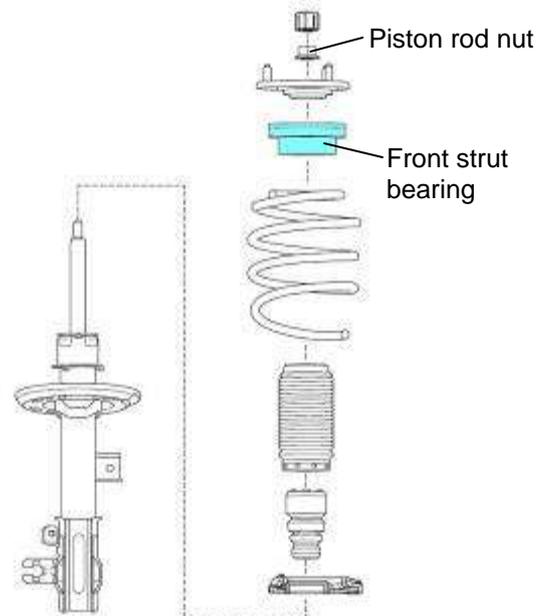
[Front shock absorber and coil spring]

Some vehicles may exhibit a knocking/squeaking noise from the front strut bearing **due to the front strut bearing damage** when driving on a rough road and/or turning the steering wheel at vehicle standstill.

The noise may occur due to the upper housing of the front strut bearing being damaged **when applying excessive force to the bearing during customer's usage**.

When you encounter a customer complaint on this concern, verify the noise comes from the upper part of front shock absorber when turning the steering wheel.

Replace the damaged strut bearing with modified one according to the Workshop Manual. Refer to [FRONT SHOCK ABSORBER AND COIL SPRING DISASSEMBLY/ASSEMBLY].
