Subject: TICKING NOISE FROM PURGE VALVE	Bulletin No: 01-012/07
	Last Issued: 05/07/2007

2005 - 2007 Mazda6 3.0L vehicles produced before Oct. 10, 2006

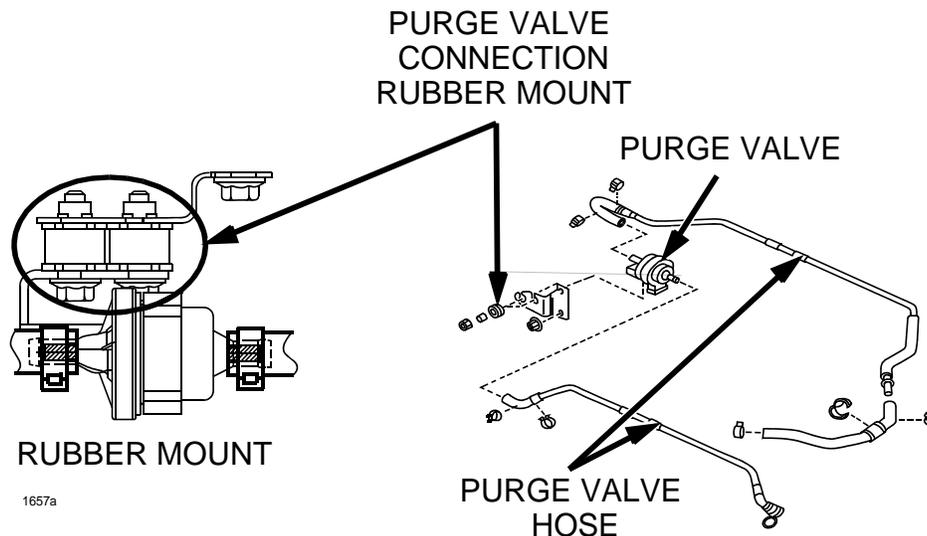
On some vehicles, a ticking noise can be heard in the vehicle cabin during slow acceleration between 900 - 1200 RPM. Due to purge valve operation, (located on bulkhead) vibration may occur and transmit noise into the vehicle cabin through the bulkhead and dash panel. As a mass-production improvement, the length and diameter of the rubber mount was increased, and the rubber was hardened. The purge valve hoses were also lengthened.

1. Verify customer concern.
2. Replace purge valve installation rubber mount and purge valve hoses with modified parts.
