Service Information

Category U	Repair Guidance	Ref. No. R107/16REV	Page 1 of 6
Coverage <input type="checkbox"/> Distributor only <input checked="" type="checkbox"/> Please inform your dealers		Date Issued December 1, 2016	
Please convey this information to your <input checked="" type="checkbox"/> Warranty Dept. <input checked="" type="checkbox"/> Parts Dept. <input type="checkbox"/> Training Dept. <input type="checkbox"/> Field Rep.		Date Revised December 22, 2016	
Applicable Model Mazda2(DJ), CX-3(DK)		Applicable Countries or Specifications Worldwide

Subject: Air Conditioner - No Cool Air (Evaporator Leakage)

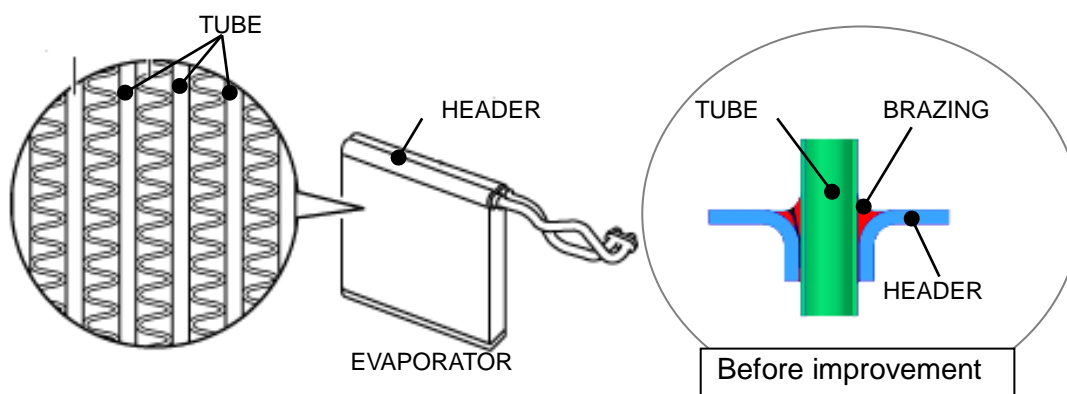
This concern is caused by A/C refrigerant leak from the joint between the tubes and the header due to improper brazing.

MASS PRODUCTION CHANGE

The configuration of the header has been changed to improve the brazing workability and performance from August 1, 2016

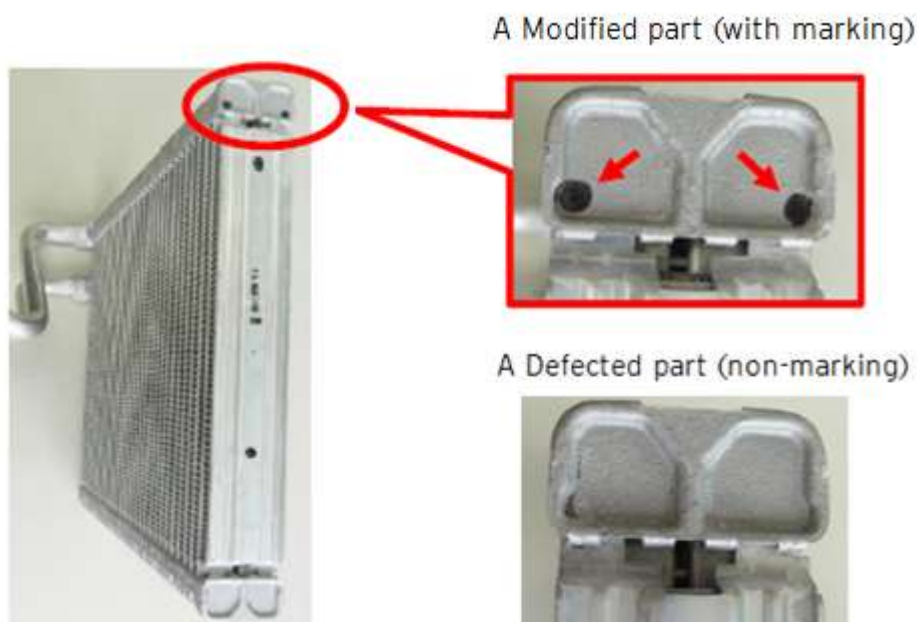
NOTE: A modified part can be distinguished by its black circled marking in the picture below.

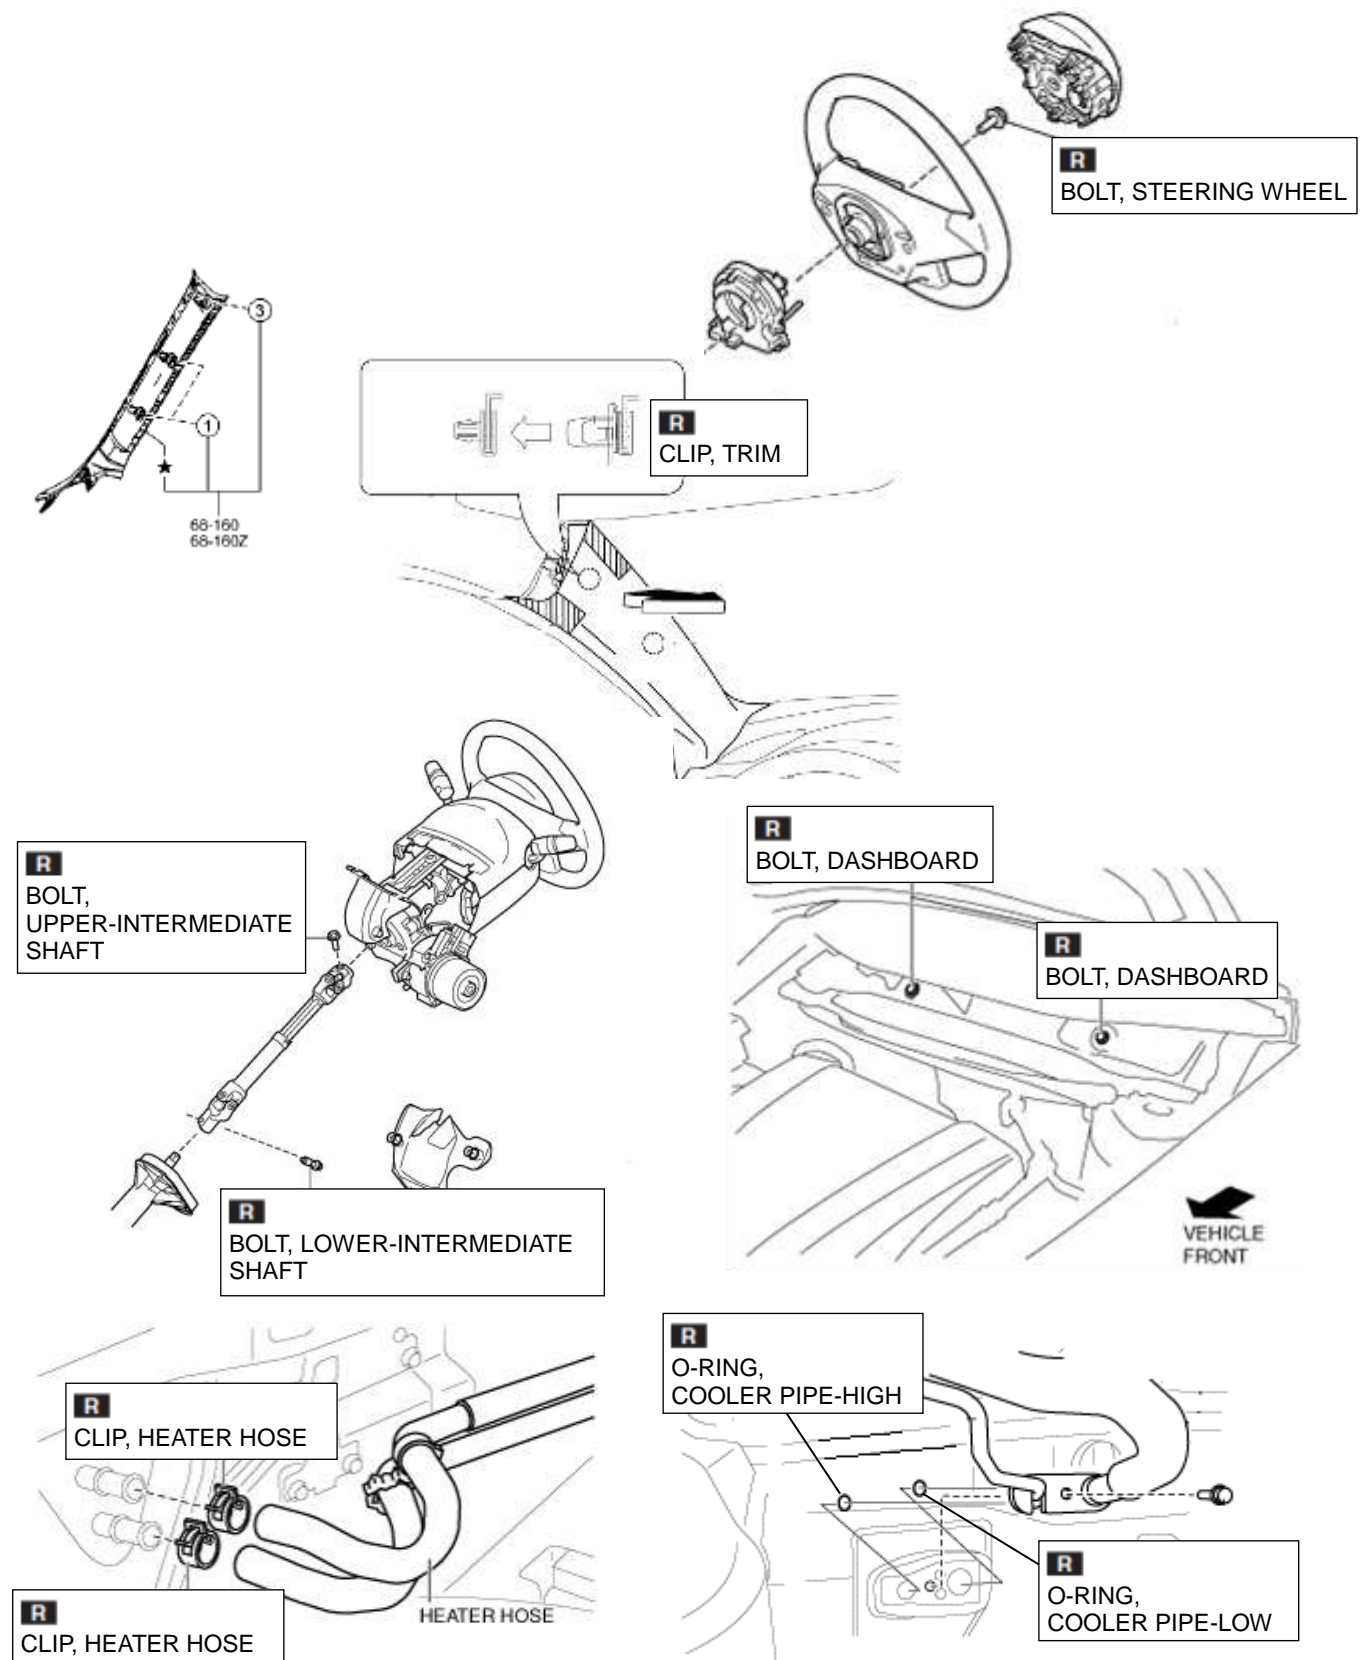
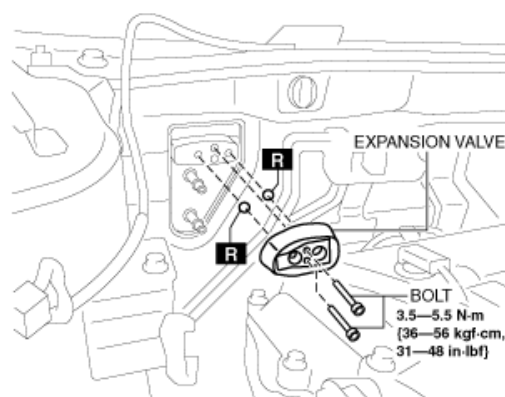
Replacement Parts Location: (Figures are for CX-3 R.H.D.)

R
O-RING, EXPANSION VALVE

R
O-RING,
EXPANSION
VALVE
