**Subject:**

**VARIABLE VALVE TIMING (VVT) NOISE AND/OR TIMING CHAIN NOISE**

**Bulletin No:** 01-012/12**Last Issued:** 04/03/2012**BULLETIN NOTE**

**APPLICABLE MODEL(S)/VINS**

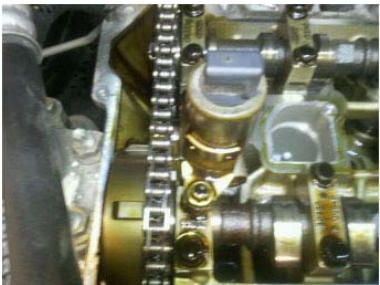
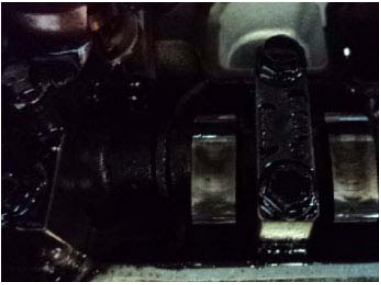
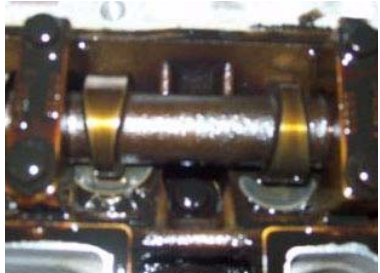
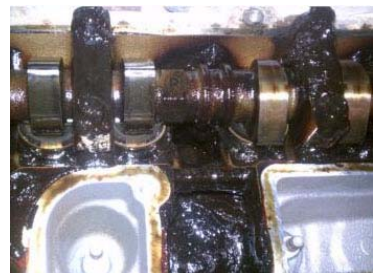
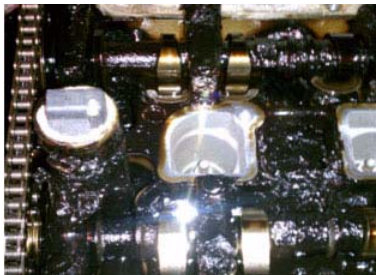
**COMPARISON PICTURES**

| OK | NEED TO CALL |
